INVESTIGATION OF THE DECEMBER 12, 2013, FATAL ROCK FALL AT 368 WEST MAIN STREET, ROCKVILLE, UTAH

by William R. Lund, Tyler R. Knudsen, and Steve D. Bowman

REPORT OF INVESTIGATION 273
UTAH GEOLOGICAL SURVEY
a division of
UTAH DEPARTMENT OF NATURAL RESOURCES
2014

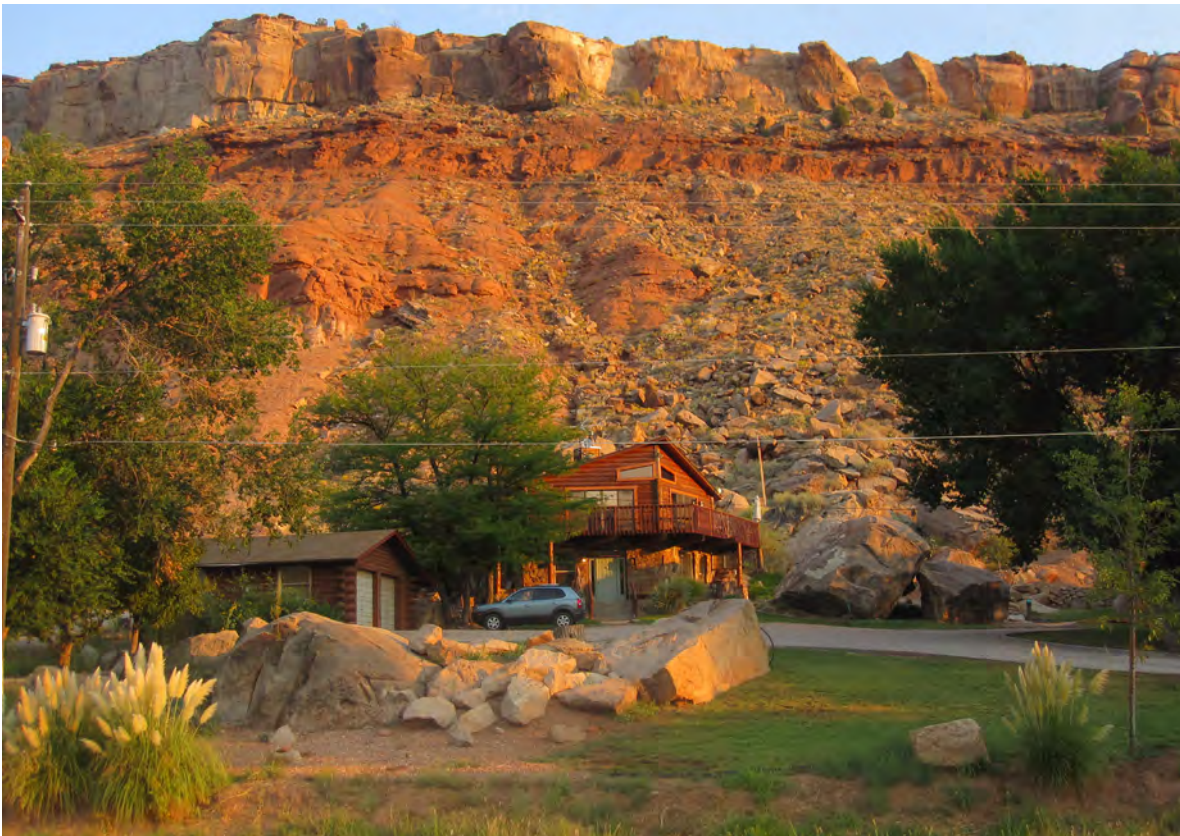
Figure 2. View of the property at 368 West Main Street in Rockville, Utah, taken on September 29, 2010. The house, garage, and car were subsequently destroyed by a rock fall on December 12, 2013; note large pre-existing rock-fall boulders within the property; view is to the north.

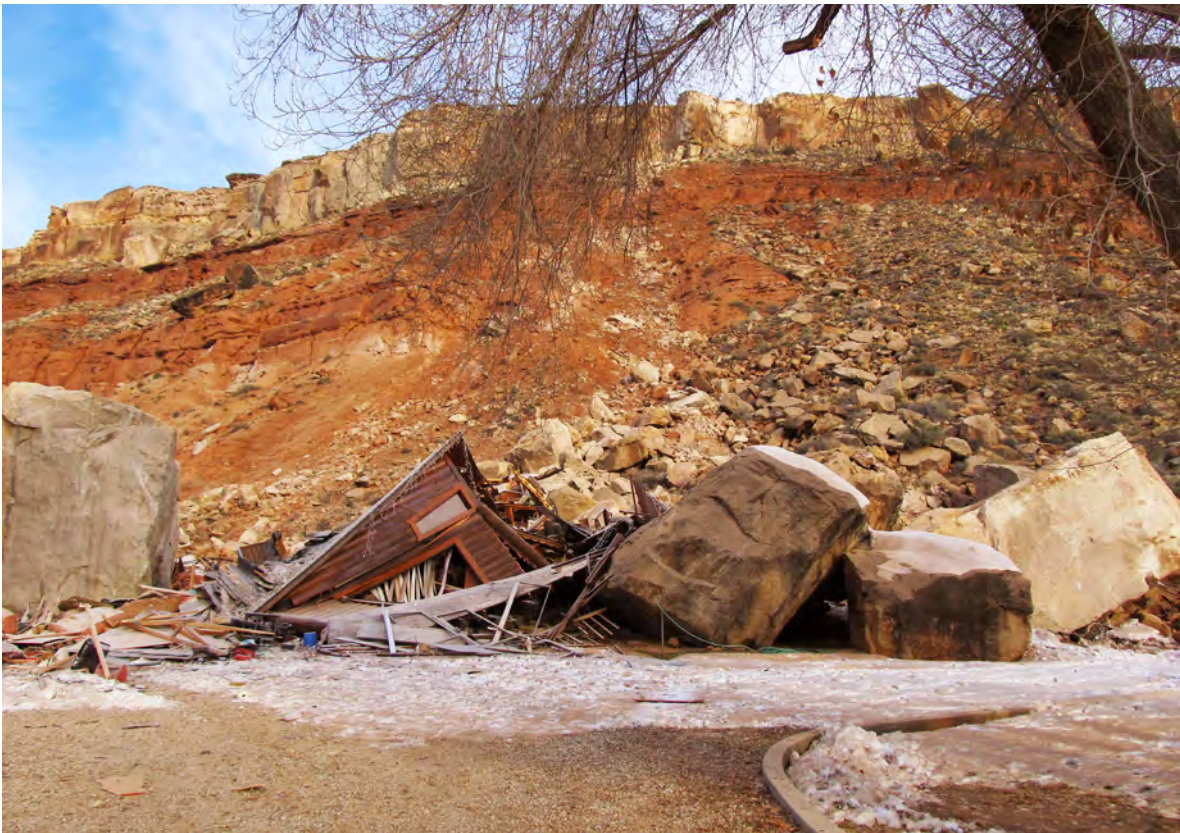
Figure 3. Remains of the house at 368 West Main Street, Rockville, Utah, following the December 12, 2013, rock fall. Photograph taken December 13, 2013, view is to the north.

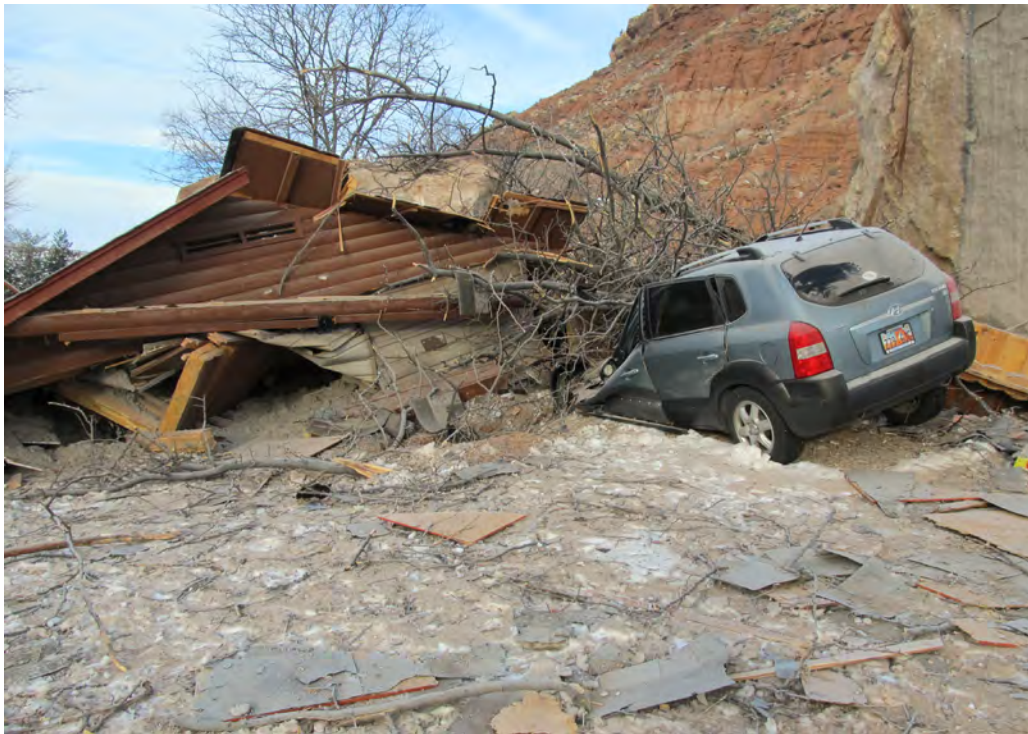
Figure 4. Detached two-car garage and car at 368 West Main Street, Rockville, Utah, destroyed by the December 12, 2013, rock fall. Photograph taken on December 13, 2013, view is to the northwest.

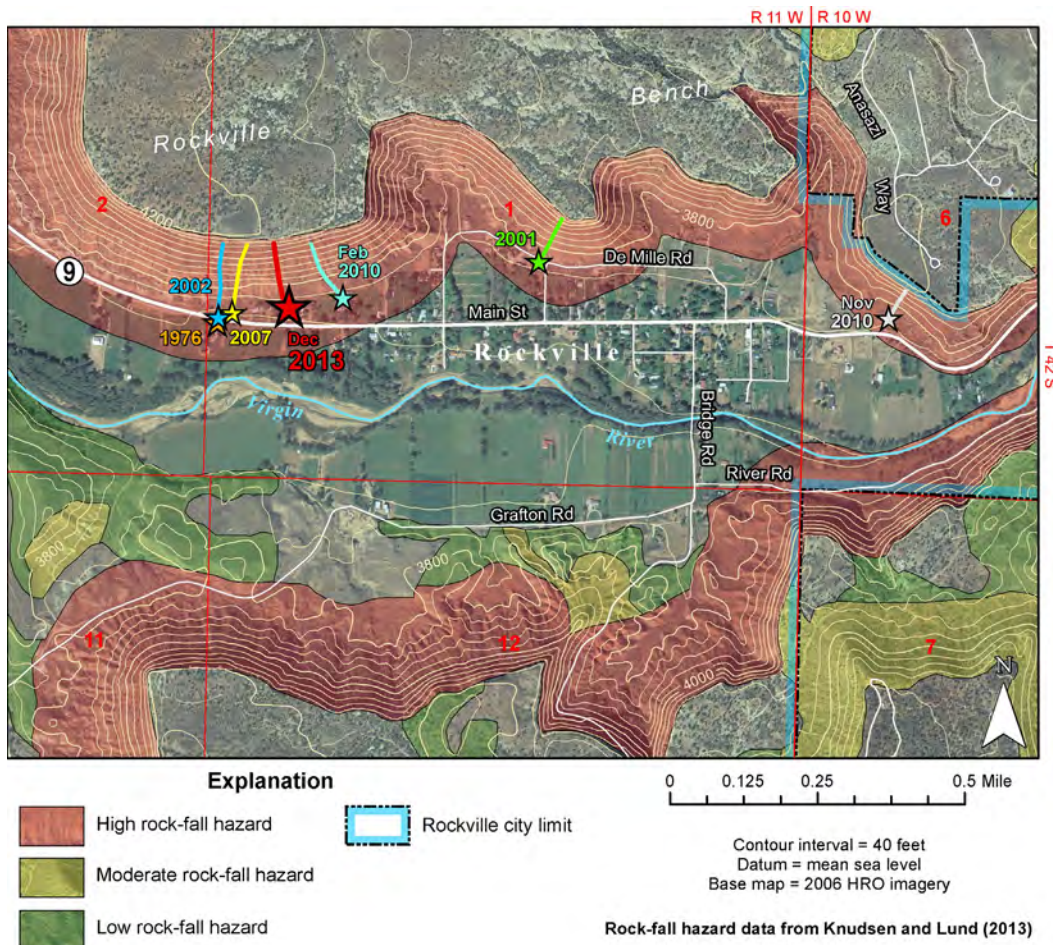
Figure 5. Rock-fall hazard zones and significant historical rock falls (stars) and their travel paths (bold colored lines) in the Town of Rockville. Modified from Knudsen (2011).

The UGS rock-fall-hazard map (Knudsen and Lund, 2011, 2013) shows the house at 368 West Main Street destroyed by the December 12th rock fall was in a high rock-fall-hazard zone (figure 5), as are many other structures in Rockville at the base of the Rockville Bench. Based on similarities between the December 12th rock-fall site and other locations at the base of the Rockville Bench in western Rockville, in particular the lack of sufficient space to construct rock-fall-risk-reduction structures, rock-fall mitigation is likely neither practical nor cost effective in those areas as well. Therefore, residents within high rock-fall-hazard areas of western Rockville have two options: (1) accept the hazard and continue

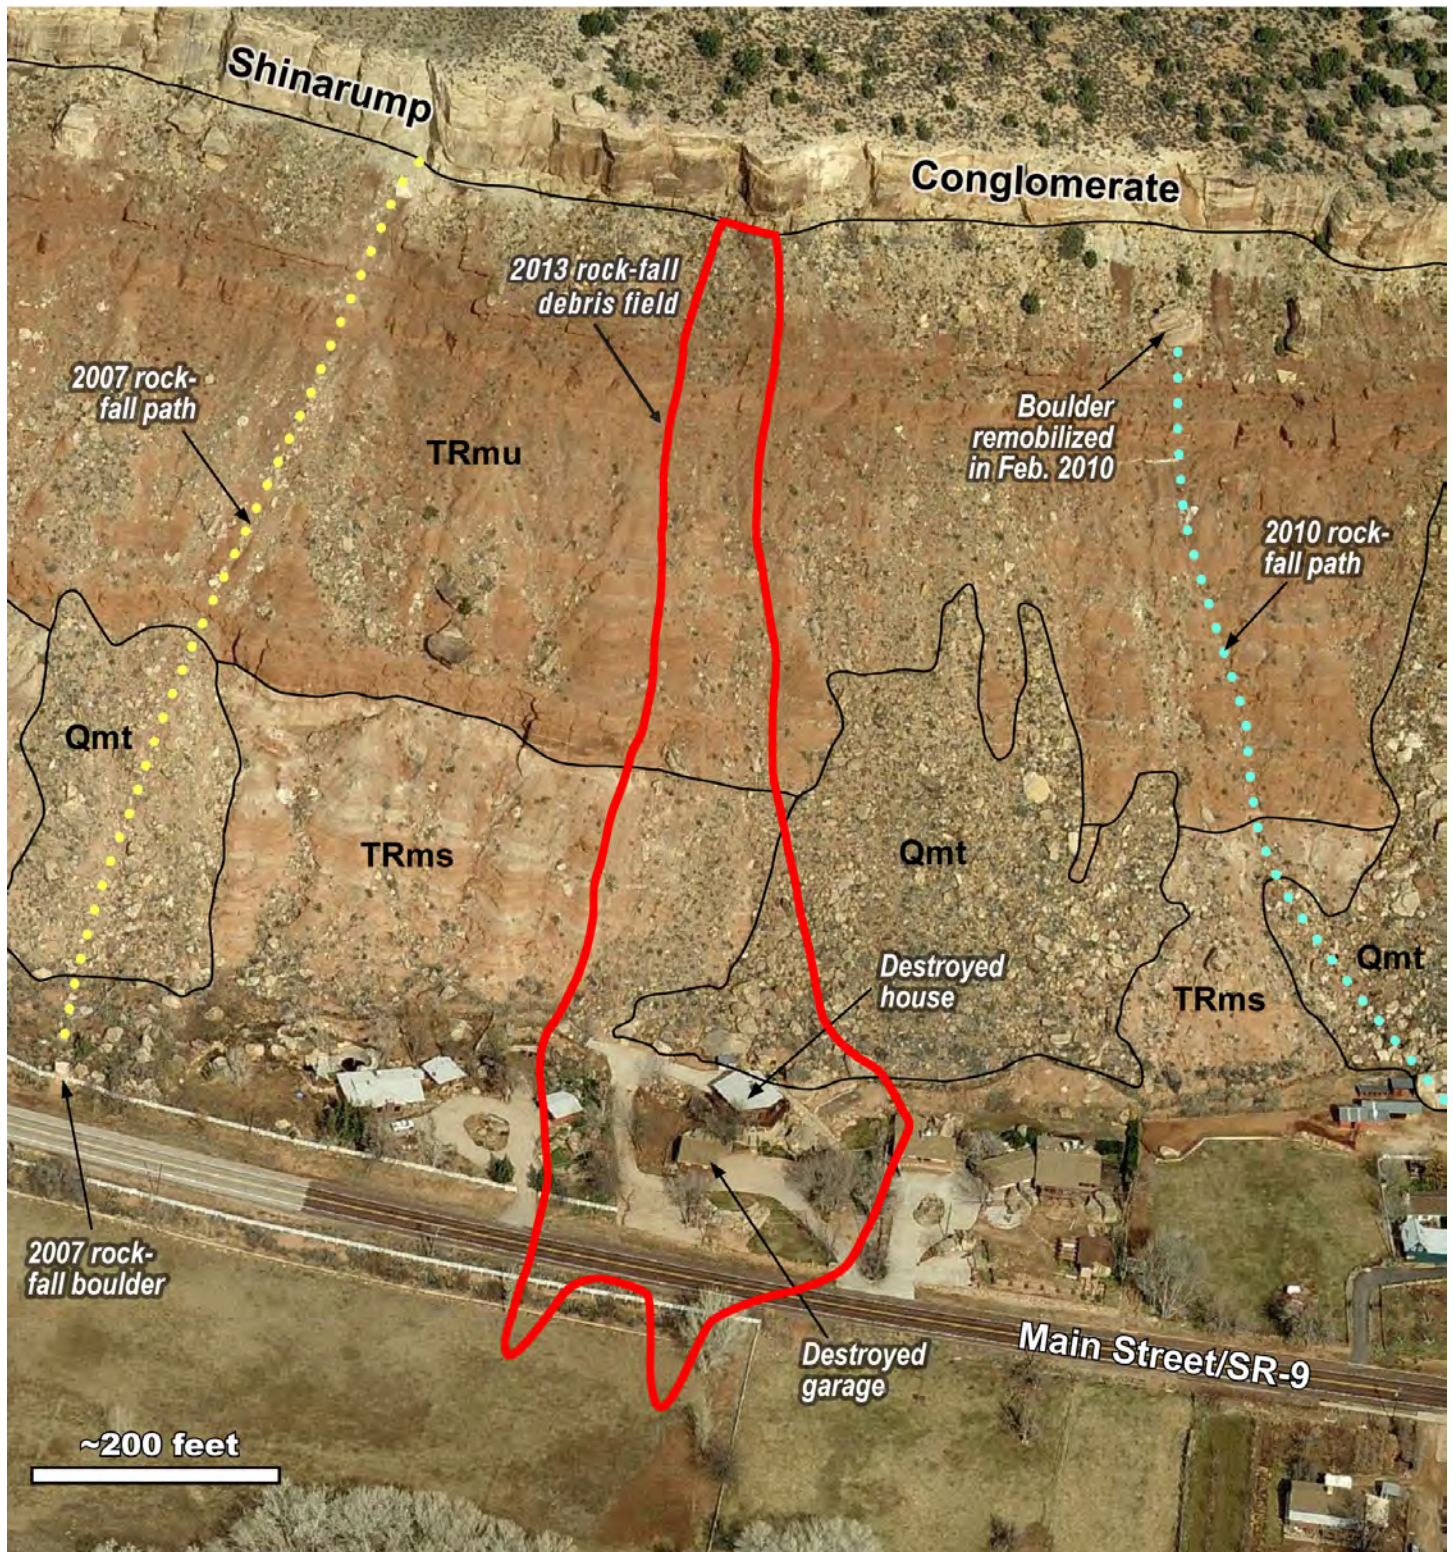
Figure 6. North-directed, circa-2008, oblique aerial view of Rockville Bench showing maximum extent of debris field of the December 12, 2013, rock fall (red line); house destroyed by the December 12, 2013, rock fall; other recent Rockville rock falls in the vicinity; and major geologic units—TRmu=upper red member of the Moenkopi Formation, TRms=Shnabkaib Member of the Moenkopi Formation, Qmt=talus (rock fall) deposits. Photo from Microsoft Bing Maps (<http://www.bing.com/maps/>).

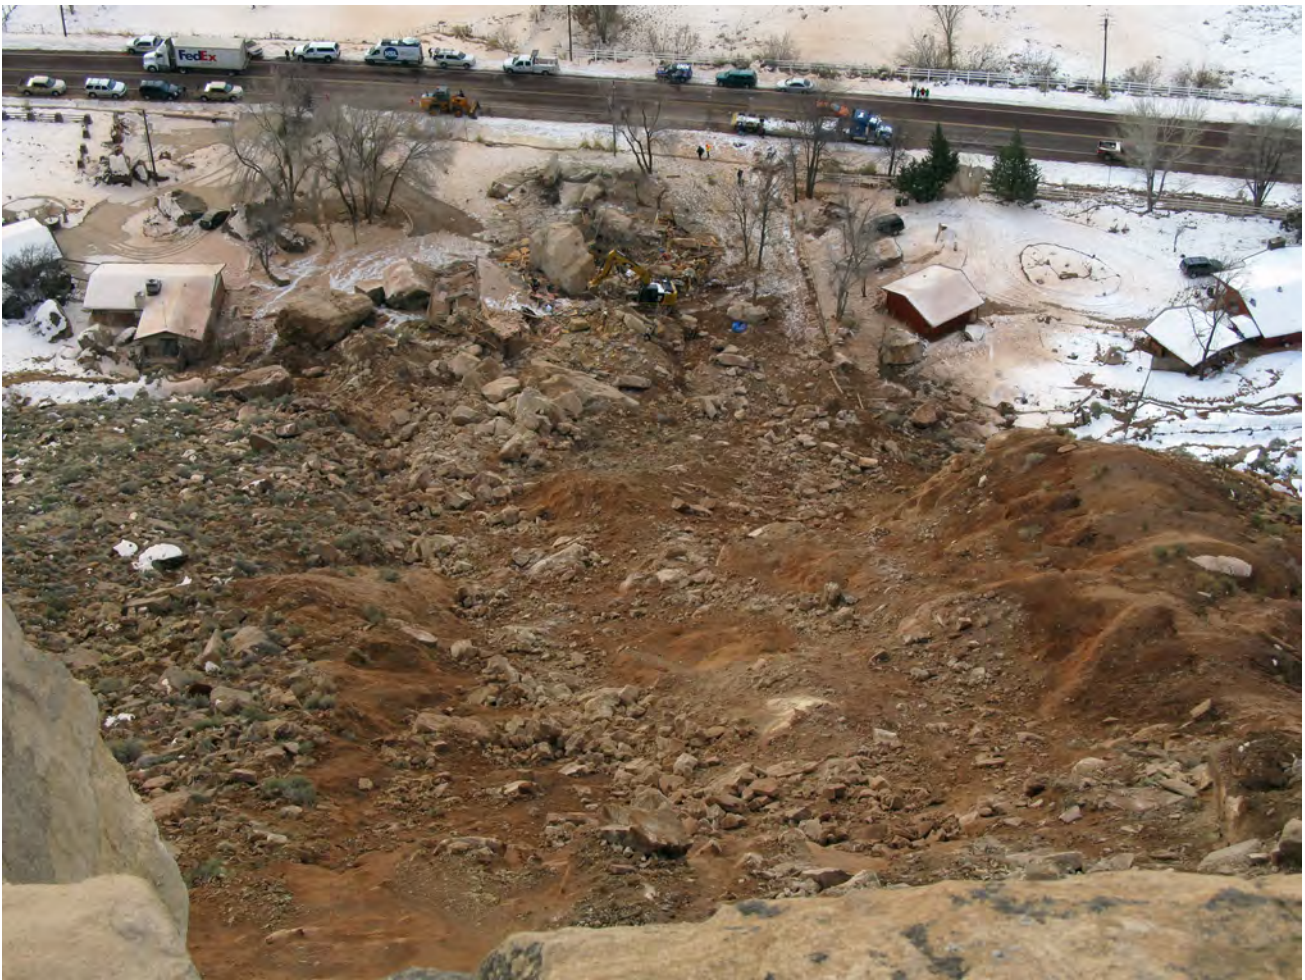
Figure 7. After falling onto the Moenkopi slope, the rock mass broke into hundreds of individual fragments ranging from cobble-size material to multiple-hundred ton boulders as it moved downslope. Photograph taken on December 13, 2013, view is to the south.

of tons, see below), which rolled and bounced rapidly down the slope (figure 7). The owner of the house immediately west of the rock-fall site was home at the time of the event, and estimated that as few as 5 seconds elapsed between hearing a sharp cracking noise that likely signaled the rock mass detaching from the cliff, and the time when boulders struck the house next door. A passing motorist photographed the dust cloud resulting from the rock fall (figure 8), and estimated the fall occurred in 10 seconds or less.

The rock fall also generated hundreds of smaller cobble- and boulder-sized fragments (figure 7), far too many to measure individually for a volume/mass estimate of the rock-fall debris that reached the site, and fresh-appearing boulders remained scattered along the rock-fall path on the slope above the site. Additionally, it is not known how much of the fresh rock on site was derived from shattering of the large boulders already present at the base of the slope prior to the December 12th rock fall.

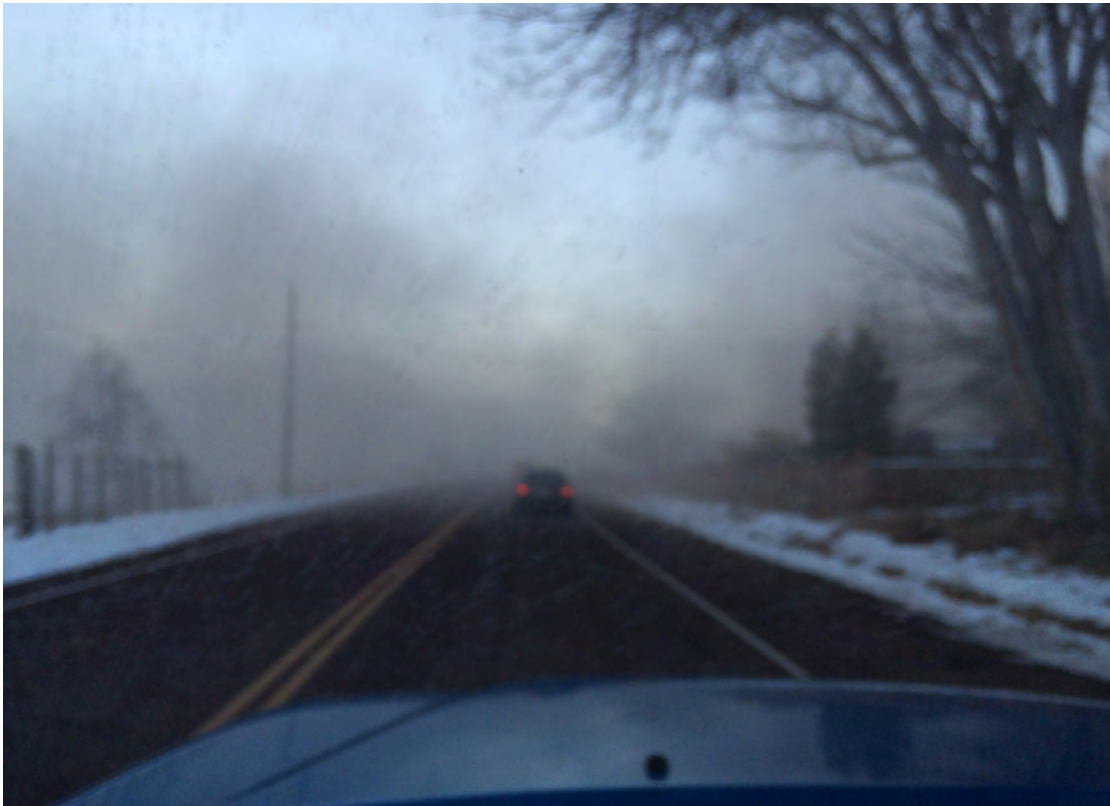
Figure 8. Dust cloud resulting from the December 12, 2013, rock fall in Rockville, Utah. The motorist who witnessed the event estimated that the duration of the rock fall was 10 seconds or less. Photograph taken by Jack Seegmiller on December 12, 2013, view is to the west.

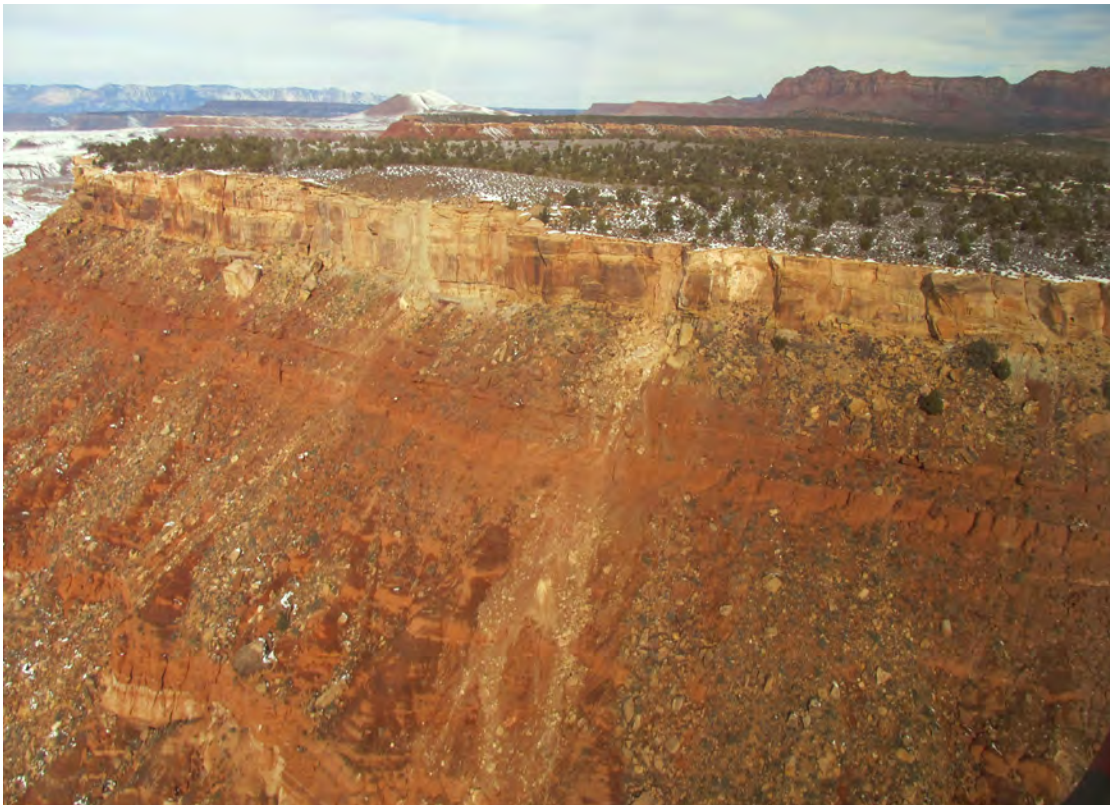
The rock-fall path was partially influenced by the presence of small, pre-existing gullies on the Moenkopi slope (figure 9), and was delineated by churned soil and vegetation, fresh rock deposition, both soil and rock gouge, and impact craters (figure 10). Some of the rapidly moving rock-fall debris collided with large, previously fallen boulders at the base of the slope (figures 2 and 6) and shattered into hundreds of additional fragments. Numerous large boulders continued beyond the base of the slope (likely including fragments shattered from the previously fallen boulders), several of which struck and destroyed a house, a two-car detached garage, and a car parked in the garage driveway at 368 West Main Street.

Figure 9. Upper part of the path taken by the December 12, 2013, rock fall. Note how pre-existing small gullies on the Moenkopi slope split and redirected a portion of the rock fall. Numerous freshly fallen boulders of unknown stability remain on the slope along the rock-fall path. Photograph taken on December 13, 2013, view is to the northwest.

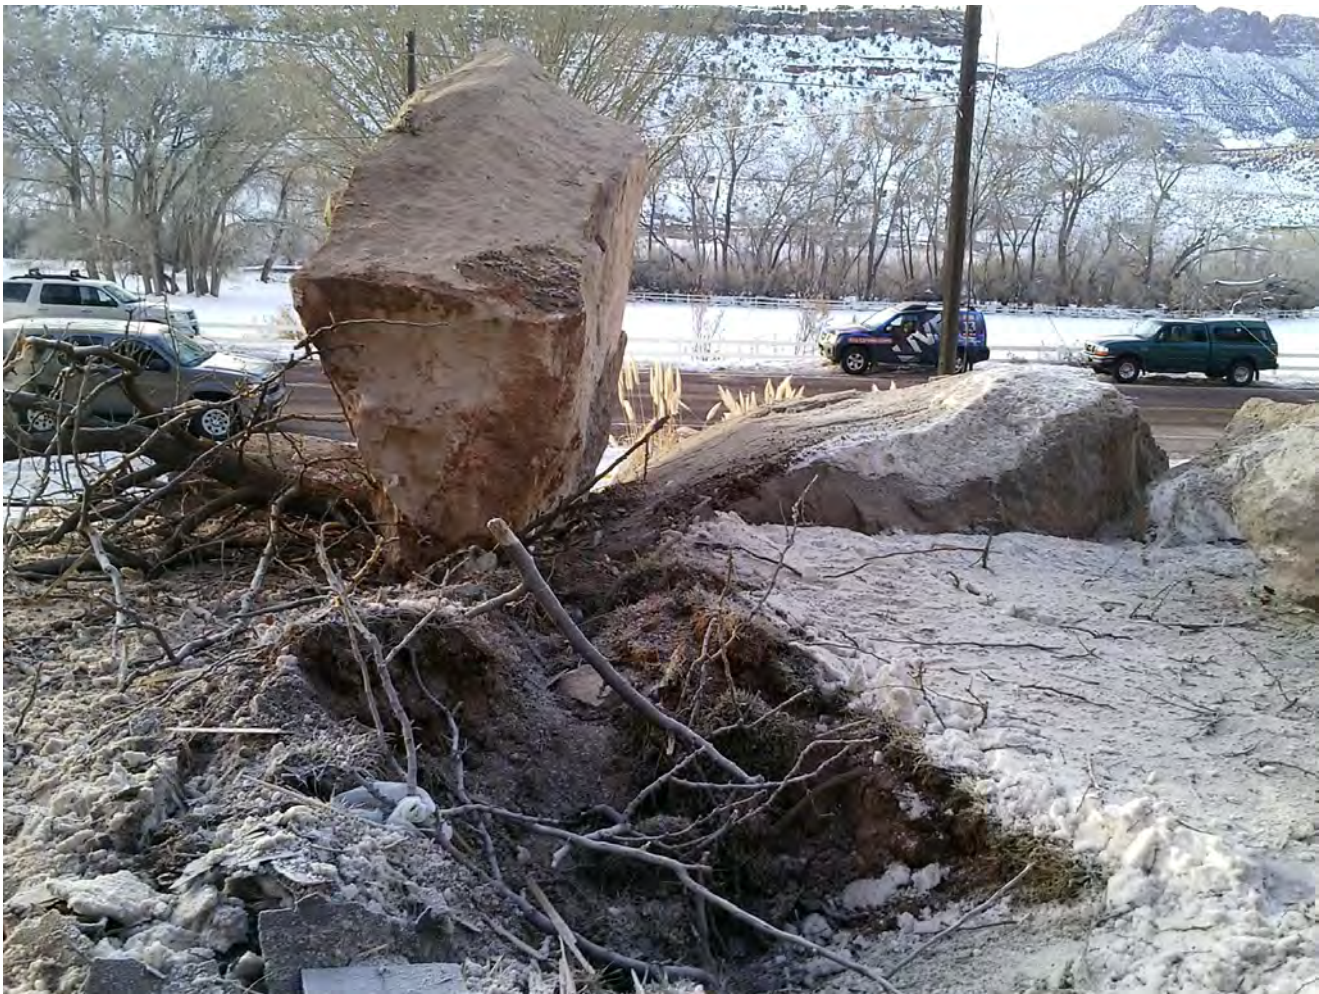
Figure 10. Example of an impact crater, gouge, and vegetative debris created by a rolling/bouncing boulder during the December 12, 2013, rock fall. Photograph taken on December 13, 2013, view is to the south.

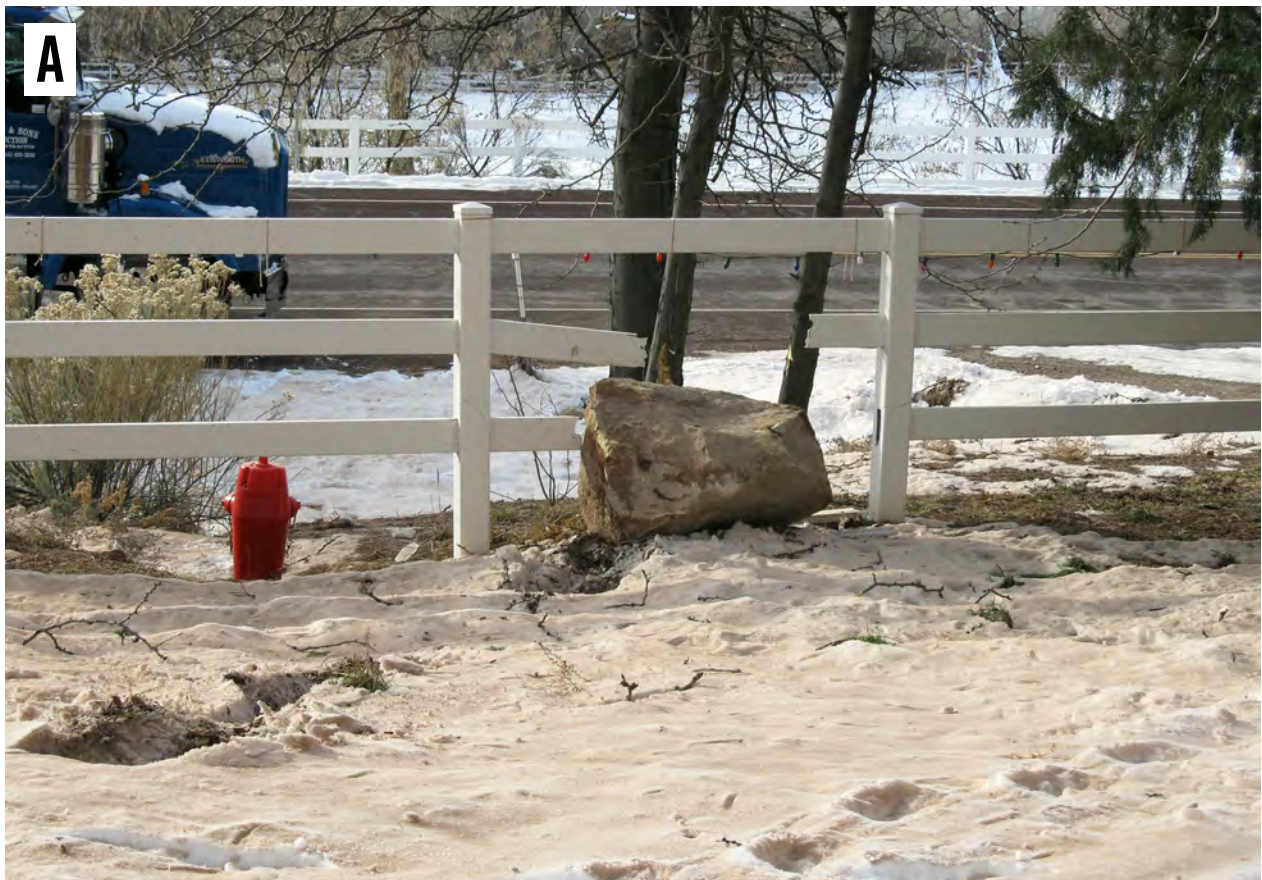
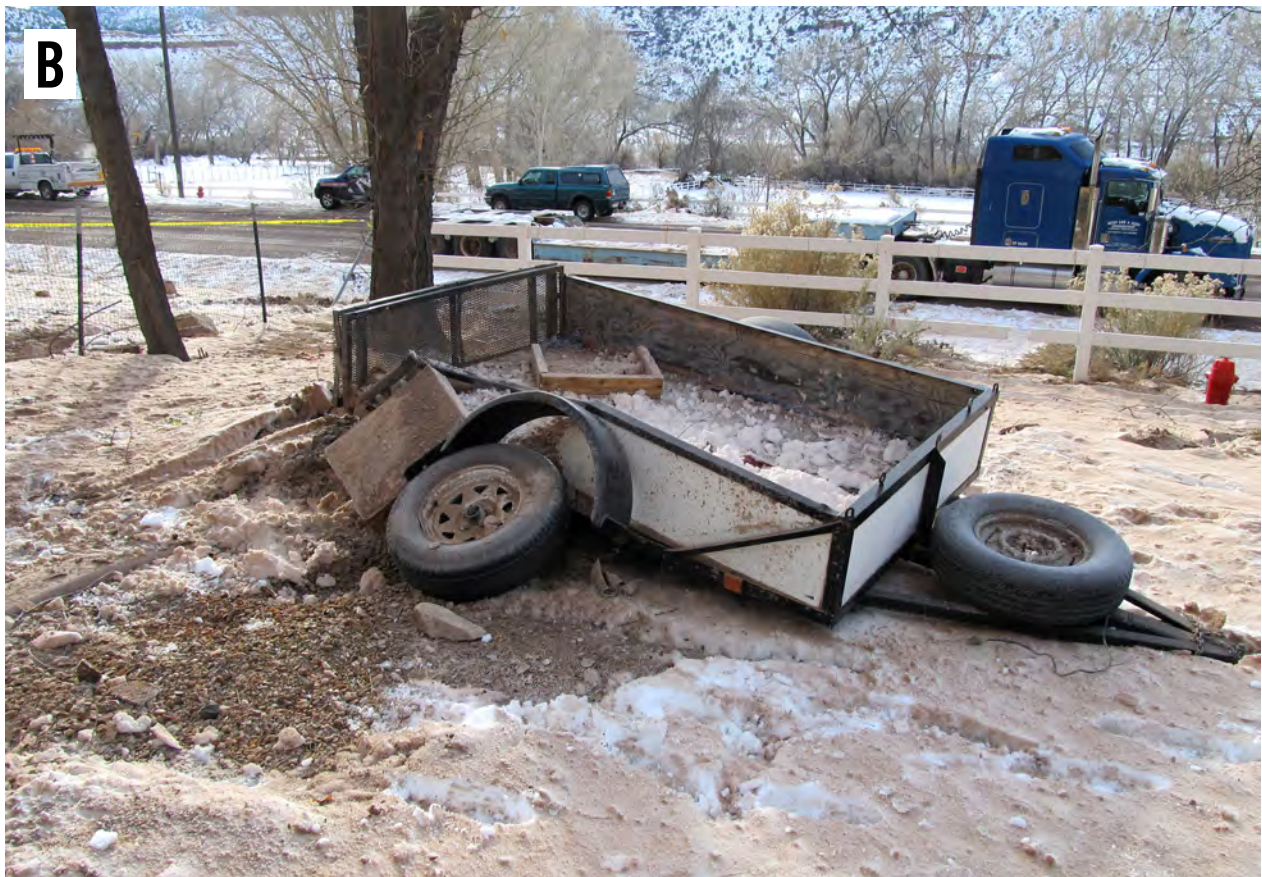
Figure 11. Boulder (A) with an estimated volume less than one cubic yard that destroyed a small utility trailer (B) on the property immediately west of the December 12, 2013, rock-fall location. Photographs taken on December 13, 2013, views are to the south.

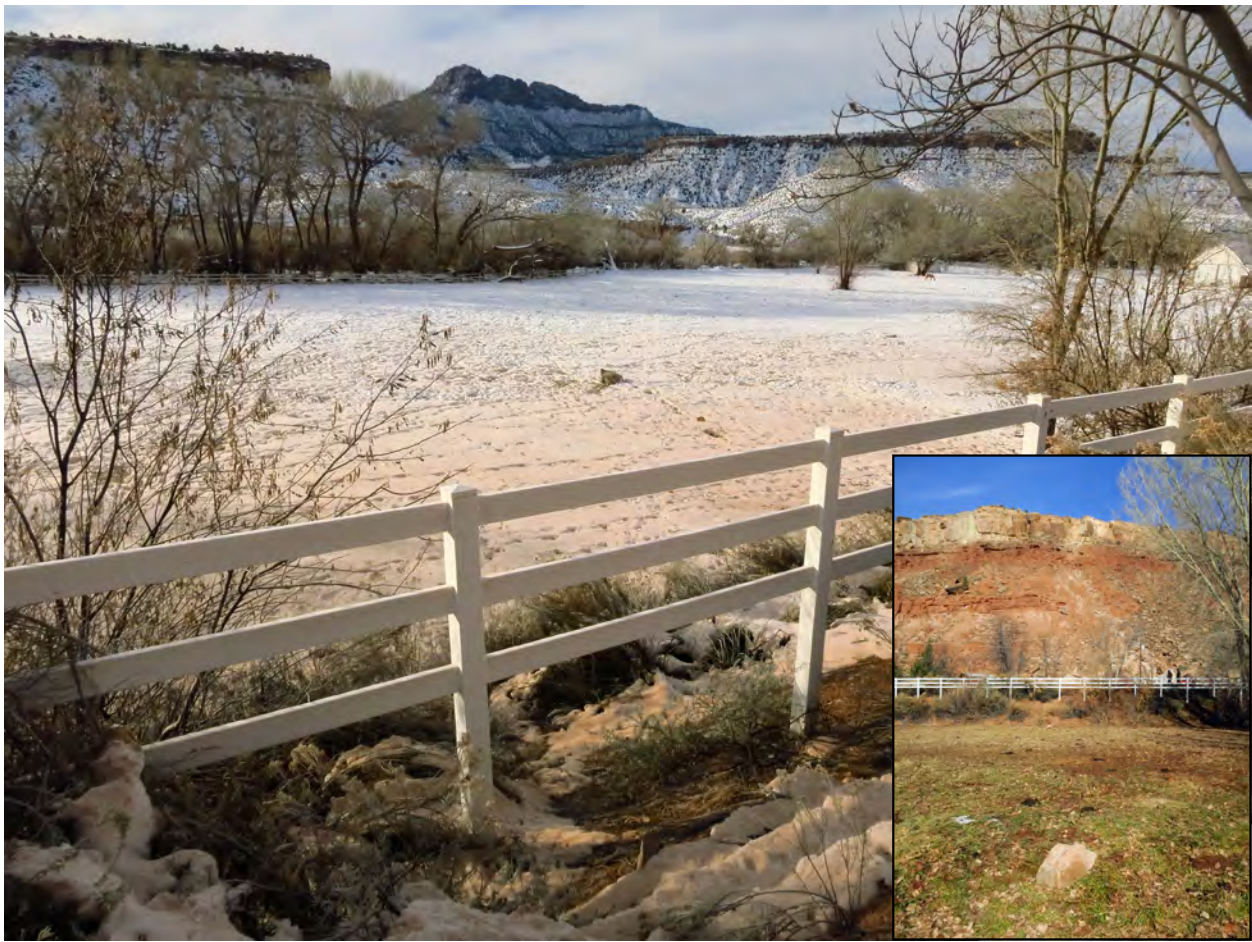
Figure 12. Largest of two boulders that represent the farthest traveled rock-fall debris from the December 12, 2013, rock fall. The boulder is in a pasture on the south side of Main Street/SR-9 directly across from the rock-fall site (see figure 6). The boulder has an estimated volume of 19 ft³ and weight of 2700 pounds, and is approximately 895 horizontal feet (map distance) from the Shinarump cliff on top of the Rockville Bench that sourced the rock fall. The boulders apparently bounced/flew across Main Street (no gouge marks in road pavement, shoulder, or embankment) and cleared both an above-ground telephone line and the fence in the foreground without damaging either. Note the beginning point of the boulder roll path in the snow. Large photograph taken on December 13, 2013, view is to the southwest. Inset photograph taken on December 17, 2013, view is to the northeast.

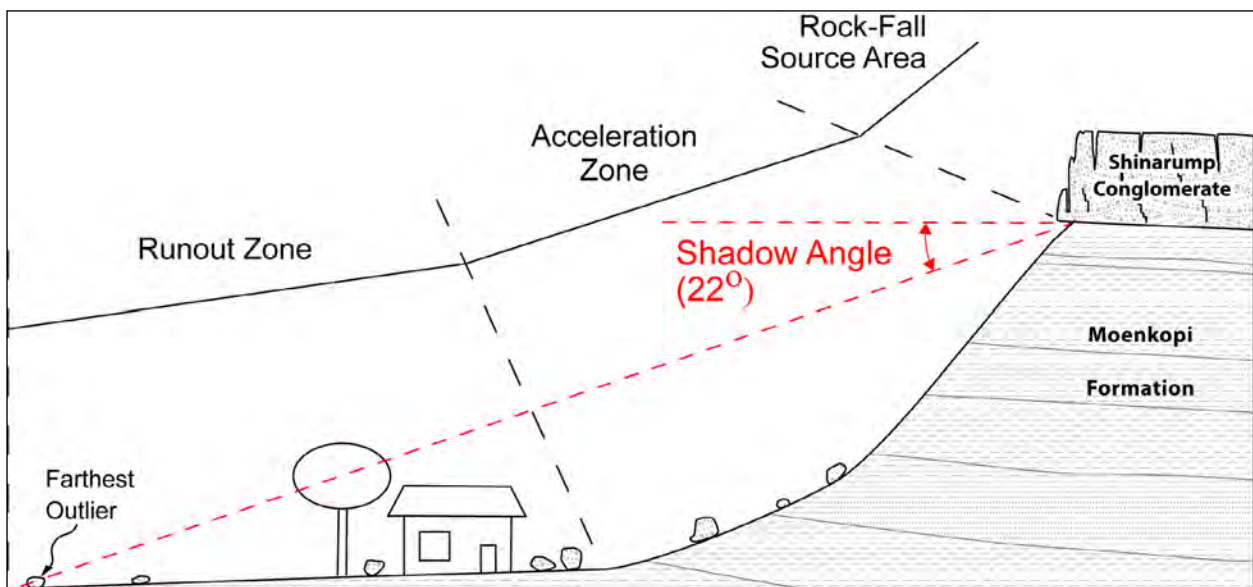
the average angle of an imaginary line extending from the bottom of a rock-fall source (in this case, the Shinarump Conglomerate) to the rock's final resting place (figure 13). Lund and others (2010) and Knudsen (2011) measured dozens of the farthest outlying boulders of rock-fall deposits in Zion National Park and Rockville, respectively, and concluded that a 22° shadow angle is a reasonable value for estimating maximum rock-fall runout distance in the Zion Canyon area.

Figure 13. Components of a characteristic path profile for rock falls sourced from Rockville Bench (modified from Lund and others, 2008).

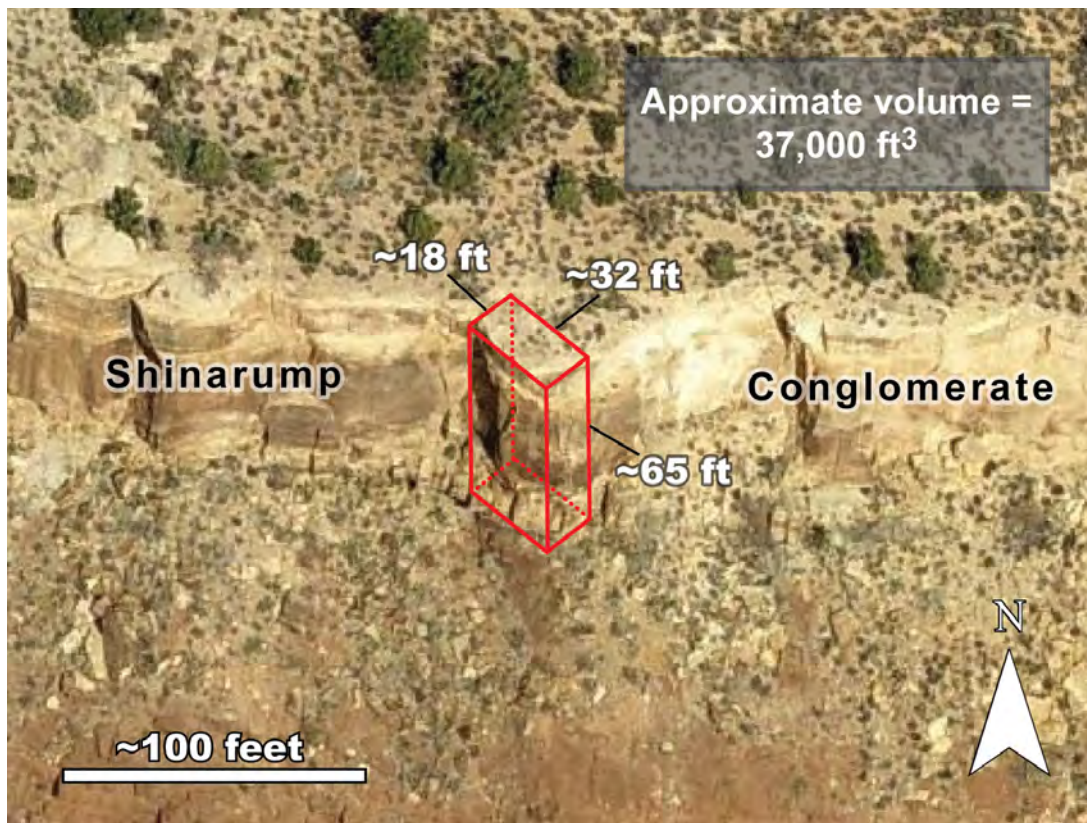
Based on aerial-photo analysis, the size of the detachment surface, thickness of the Shinarump Conglomerate Member, and amount of material at the bottom of the slope, we estimate the rock mass was roughly rectangular with dimensions of about 18 x 32 x 65 feet (figure 14) and a volume of approximately 37,000 ft³ (1400 yd³); all volume and mass estimates are rounded to two significant figures. Using a specific gravity of 2.3 for the Shinarump Conglomerate, the weight of the rock mass that sourced the rock fall was approximately 2700 tons. The largest rock-fall boulder to reach the site weighed an estimated 520 tons and came to rest within the shattered remains of the house (figure 15). A second, very large boulder with an estimated weight of 490 tons (figure 16) came to rest within several feet of the house to the east. Other large boulders ranging from 20 to likely greater than 100 tons also reached the site. Large boulders mostly buried by the rubble of the house and garage could not be accurately measured for a volume estimate, but the boulder that hit the car in the driveway (figure 17) weighed an estimated 41 tons, as did the largest boulder to reach the property immediately west of the site (figure 18).

Figure 14. Circa-2008 oblique aerial view of cliff face and source area showing estimated rock mass dimensions. Photo from Microsoft Bing Maps (<http://www.bing.com/maps/>).

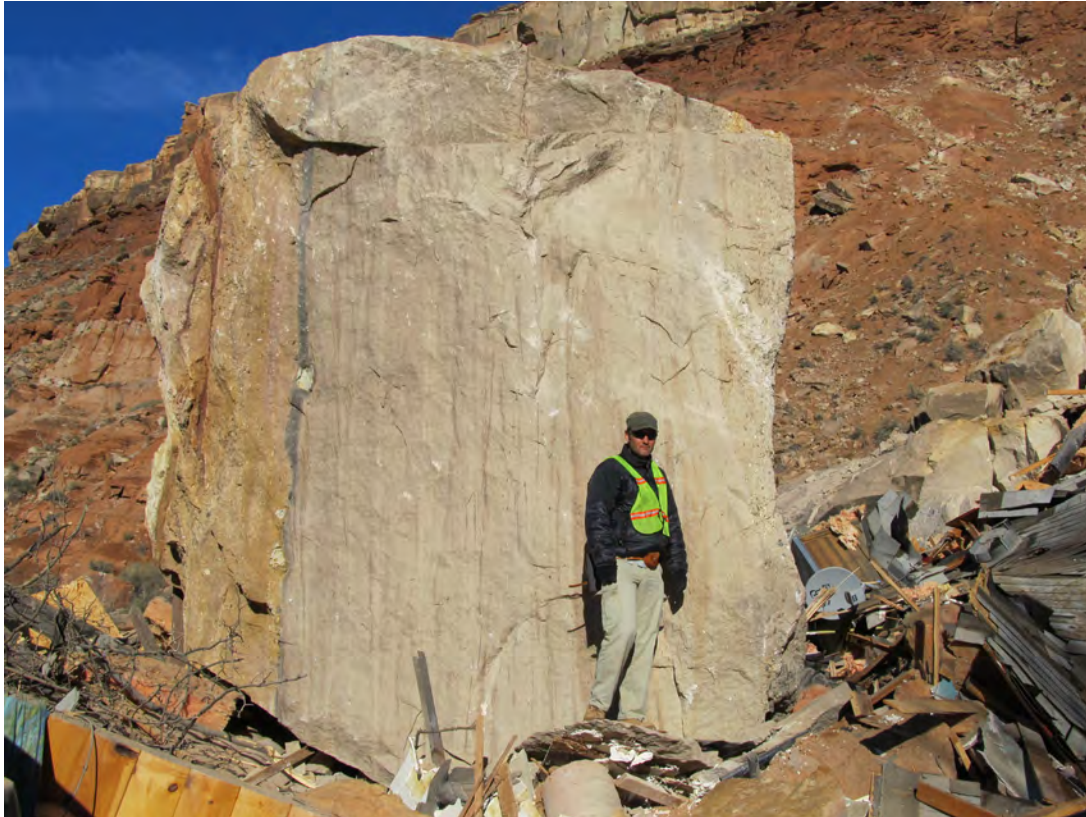
Figure 15. The largest boulder to reach the December 12, 2013, rock-fall site. The boulder is situated within the debris of the destroyed house, and has an estimated volume of 270 yd³ and mass of 520 tons; average boulder dimensions are 27 x 16 x 16.8 feet. Photograph taken December 17, 2013, view is to the north.

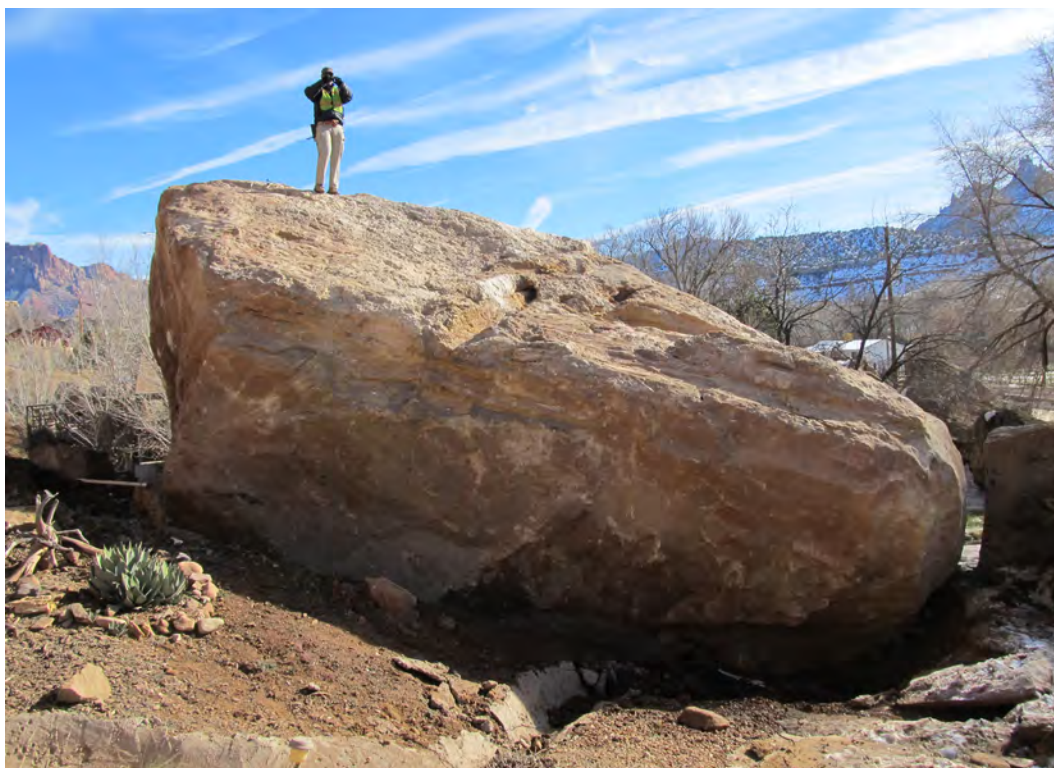
Figure 16. Second largest boulder to reach the December 12, 2013, rock-fall site. This boulder came to rest a few feet from the house on the property immediately east of the rock-fall site, and has an estimated volume of 250 yd³ and mass of 490 tons; average boulder dimensions are 38 x 13.75 x 13 feet. Photograph taken on December 17, 2013, view is to the southeast.

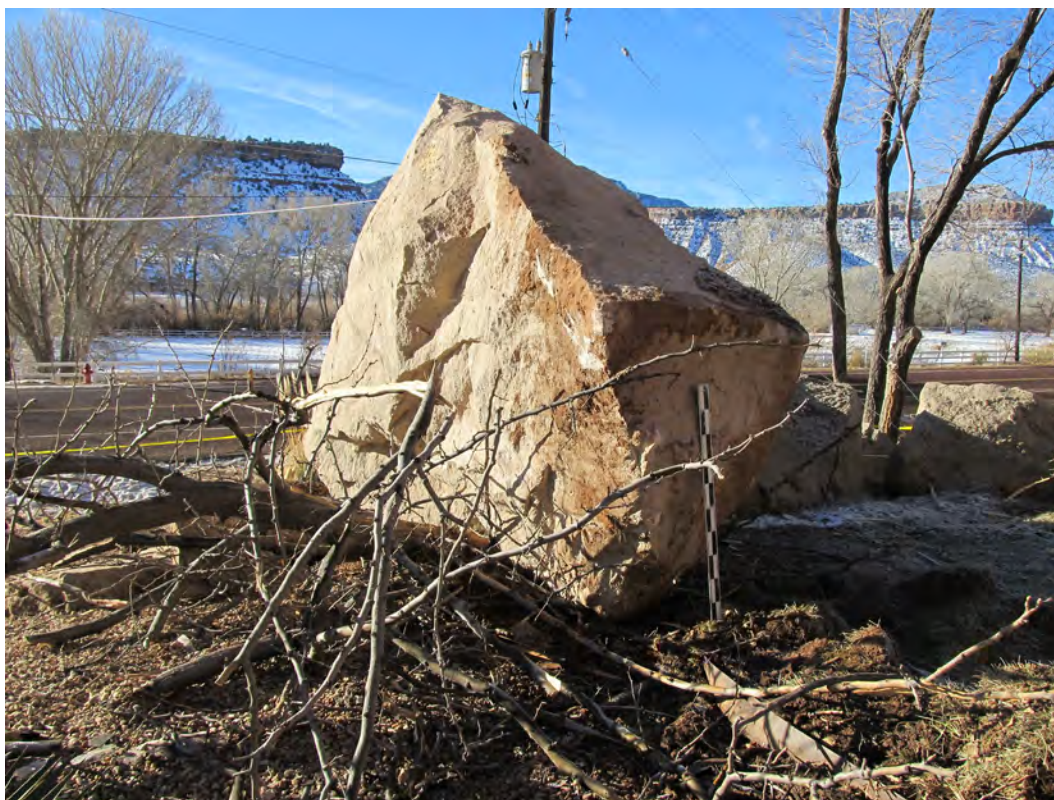
Figure 17. Boulder that destroyed the car during the December 12, 2013, rock fall; scale provided by a 1-meter stick marked in 10-centimeter increments. After striking the car, this boulder bounced across the remainder of the driveway (no gouge marks) before churning up and coming to rest on the lawn. The boulder has an estimated volume of 21 yd³ and mass of 41 tons; average boulder dimensions are 7.9 x 15.9 x 4.5 feet. Photograph taken on December 17, 2013, view is to the southwest.

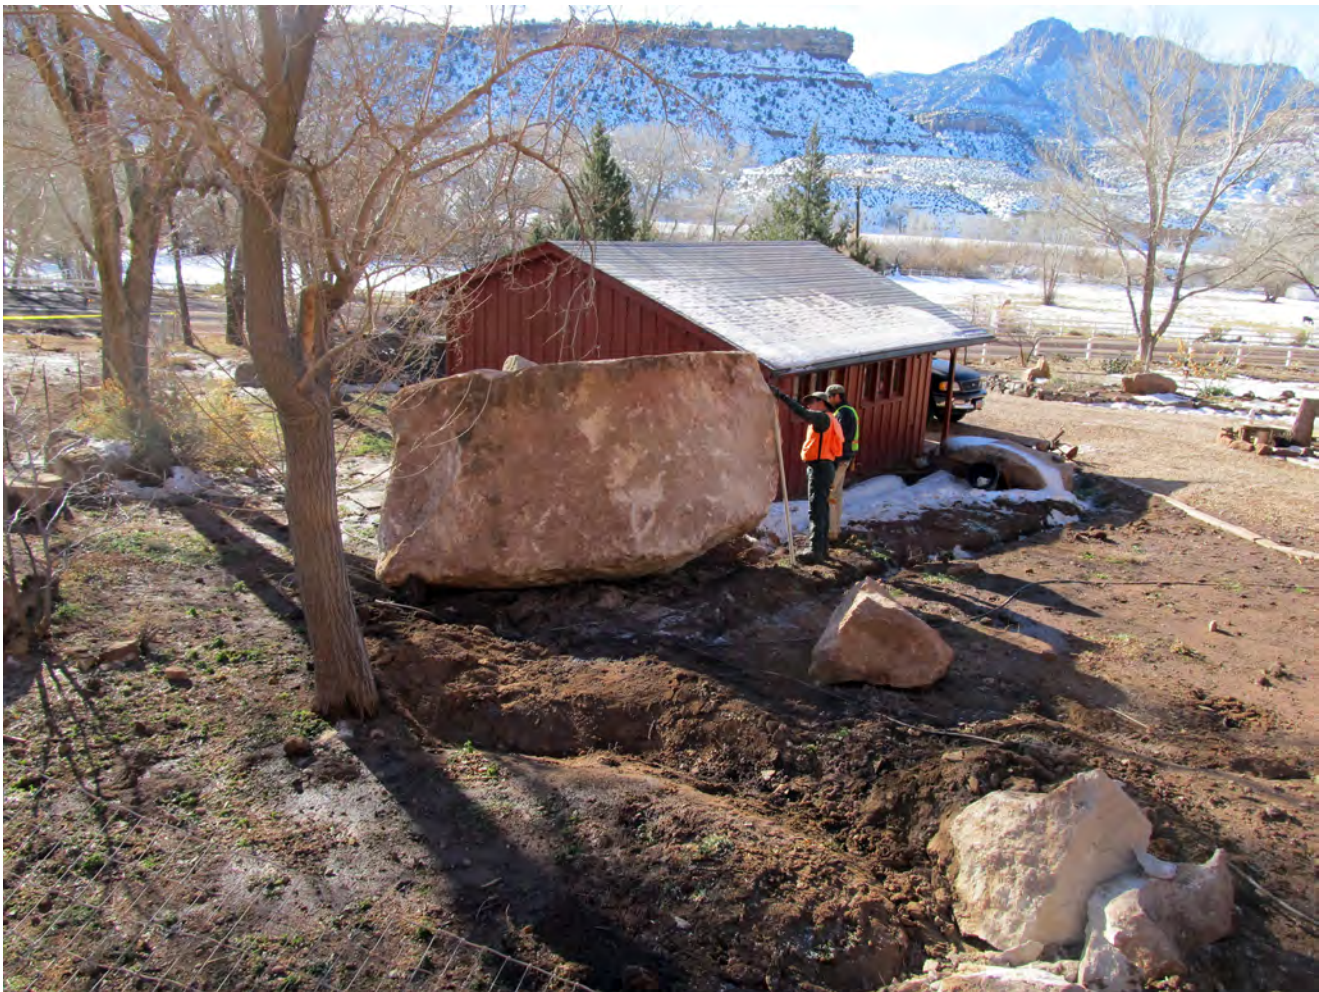
Figure 18. Largest boulder to reach the property immediately west of the December 12, 2013, rock-fall site. The boulder has an estimated volume of 21 yd³ and mass of 41 tons; average boulder dimensions are 7.5 x 11 x 7 feet. Photograph taken on December 17, 2013, view is to the southwest.
