INVESTIGATION OF THE DECEMBER 12, 2013, FATAL ROCK FALL AT 368 WEST MAIN STREET, ROCKVILLE, UTAH

by William R. Lund, Tyler R. Knudsen, and Steve D. Bowman

REPORT OF INVESTIGATION 273
UTAH GEOLOGICAL SURVEY
a division of
UTAH DEPARTMENT OF NATURAL RESOURCES
2014

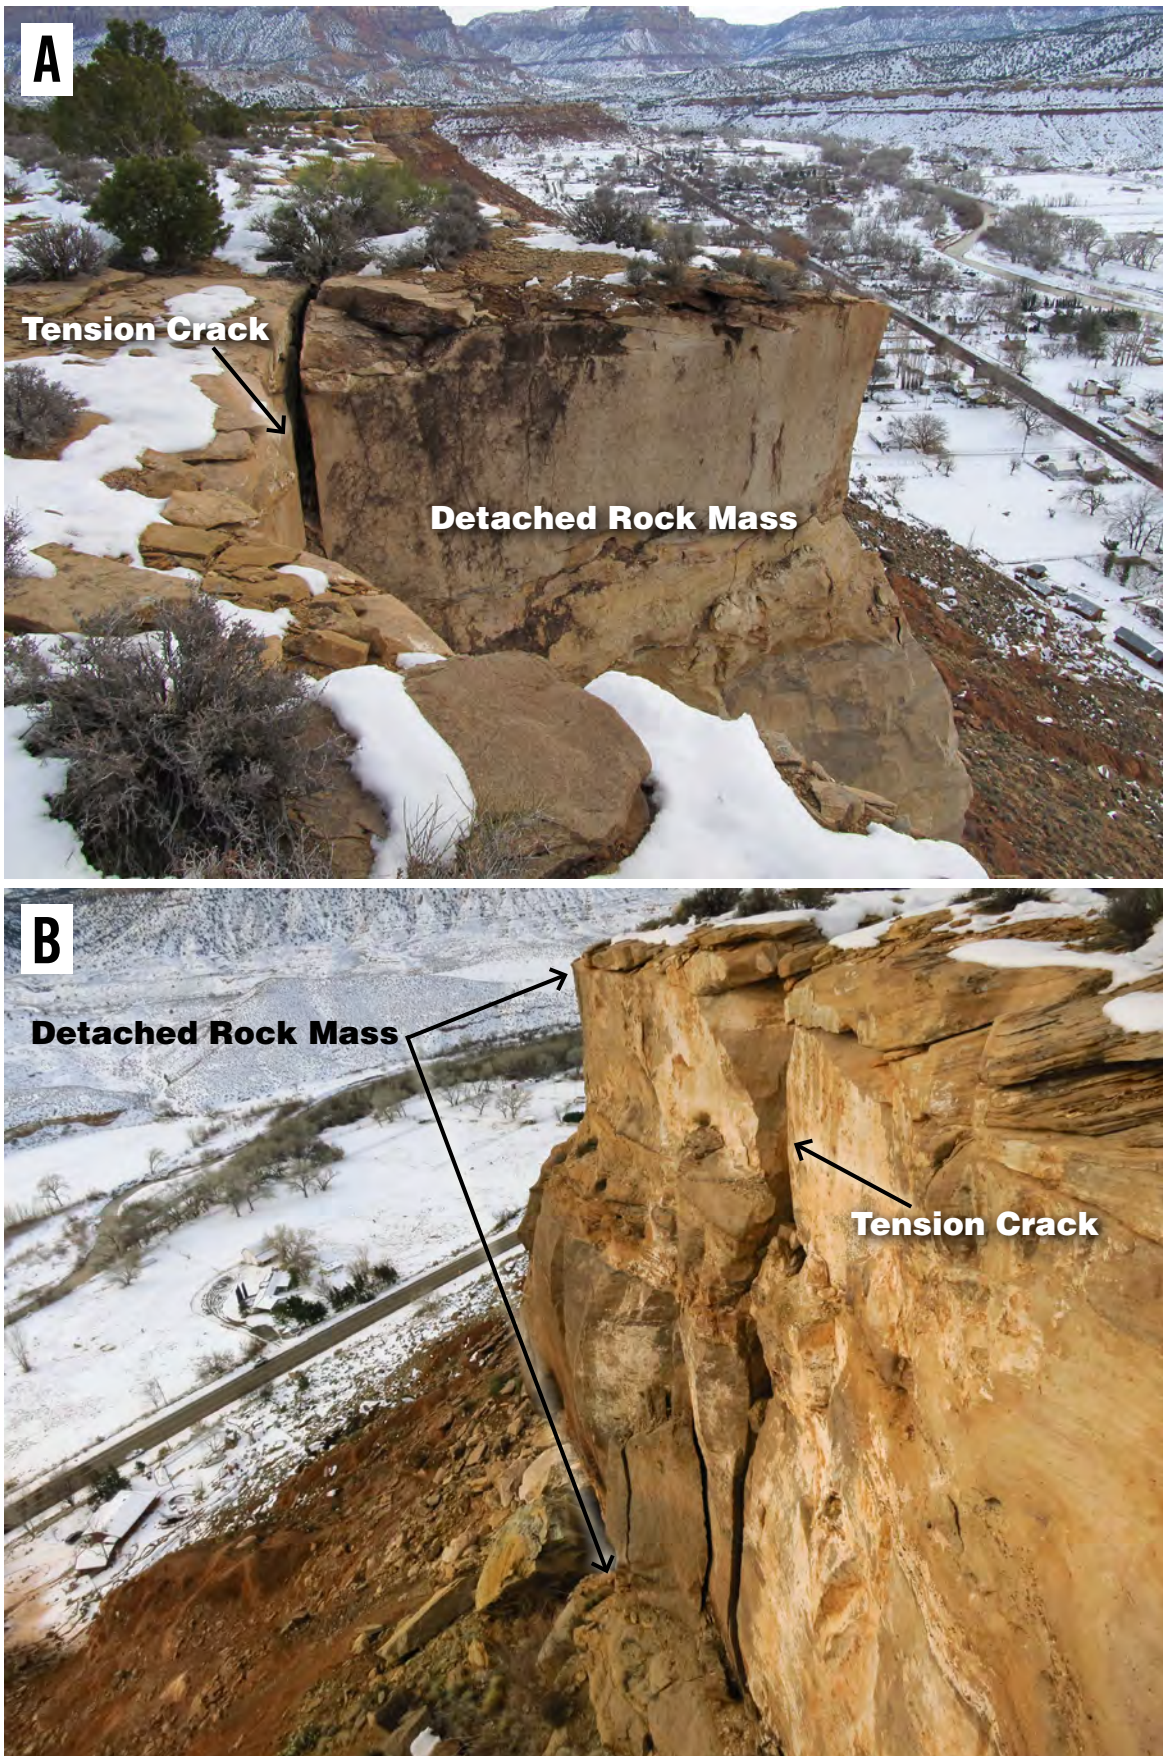
Our helicopter and foot reconnaissance of the cliff at the top of the Rockville bench conducted with Chief Wright, showed that a second, large, joint-controlled rock mass is partially detached from the cliff face (figure 19) above the site, and could fall at

Figure 19. Partially detached rock mass (A) view toward the east and (B) view toward the west still present at the face of the Shinarump cliff above the location of the December 12, 2013, rock fall at the time of this investigation. Photographs taken on December 13, 2013.

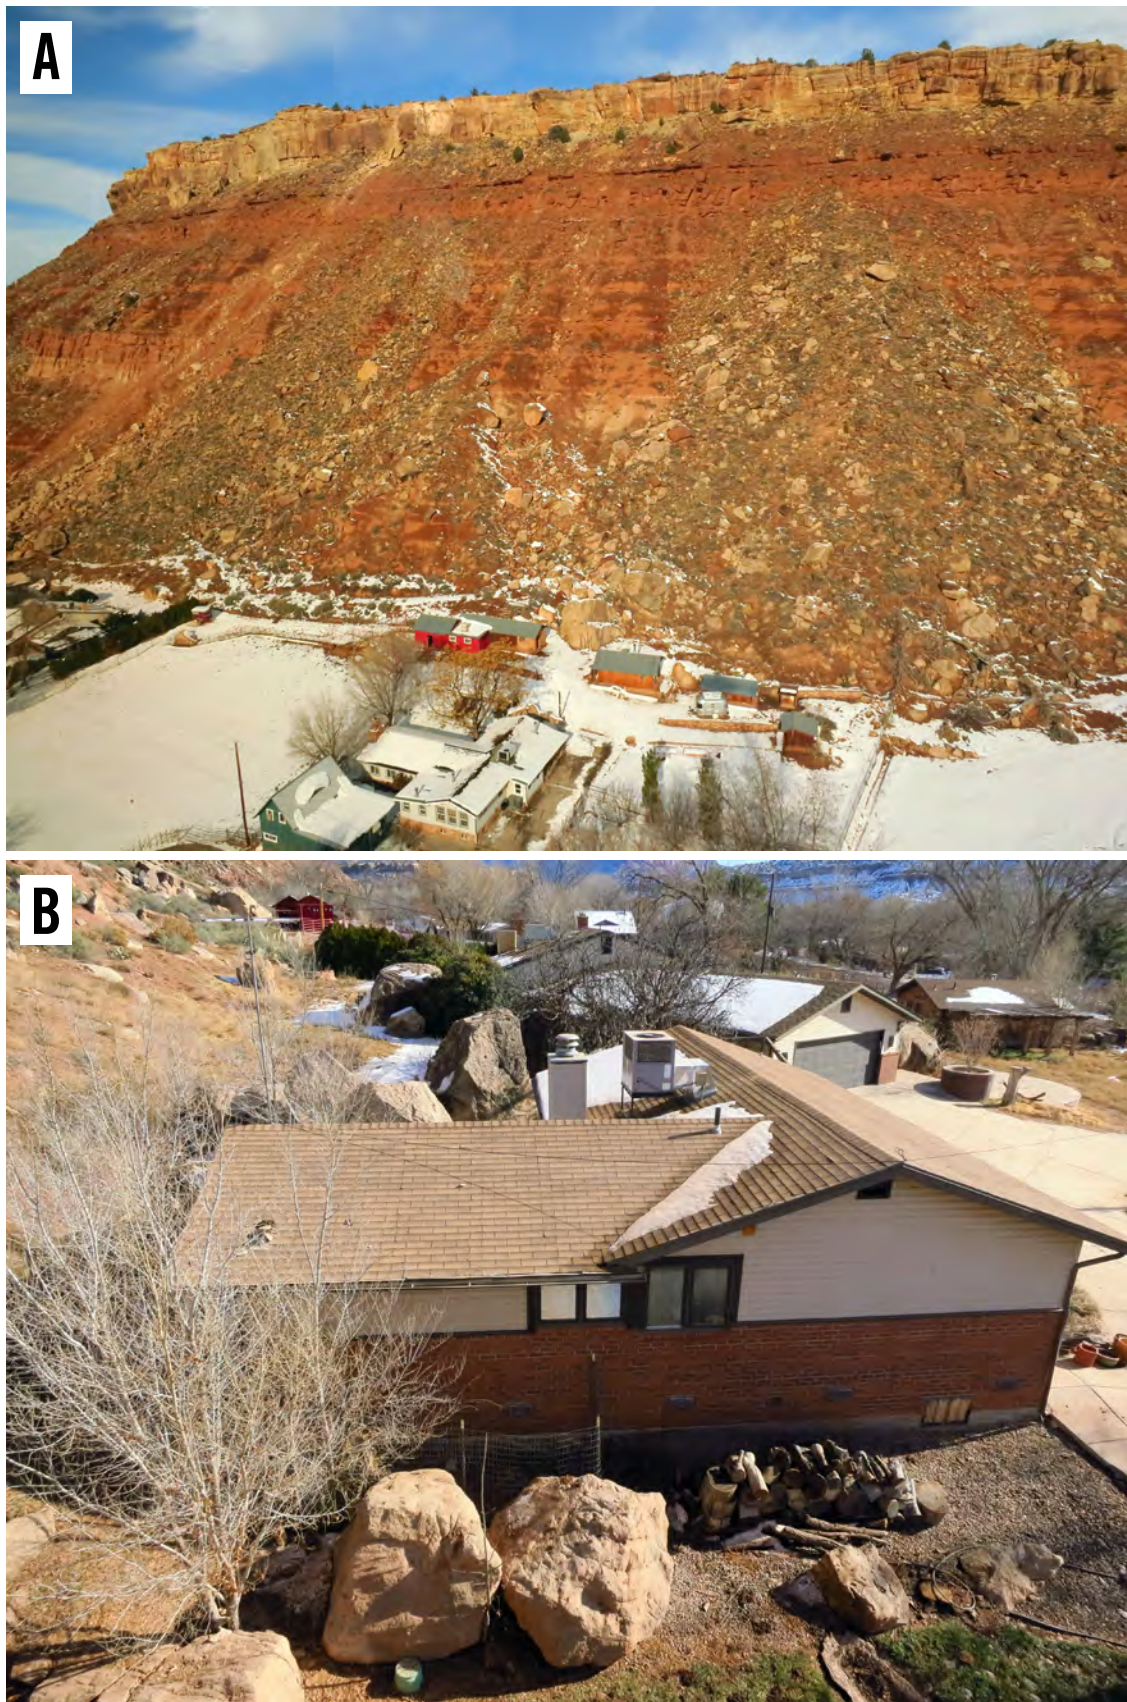
Figure 20. Two views showing structures endangered by rock falls along the base of the Rockville Bench in Rockville, Utah. (A) The white house in the foreground was struck by a rock fall in February 2010. (B) The house in the foreground is immediately east of the December 12th, 2013, rock-fall site and was struck by small rock-fall fragment; additionally, a very large boulder (figure 16) from that event came to rest only a few feet from this house. Boulders near homes in the middle and far distance are from previous rock falls of unknown timing.
